Mobile Intel[®] Pentium[®] II Processor Specification Update

Release Date: August 2006

Order Number: 243887-054

The Mobile Pentium[®] II processor may contain design defects or errors known as errata which may cause the product to deviate from published specifications. Current characterized errata are documented in this Specification Update.

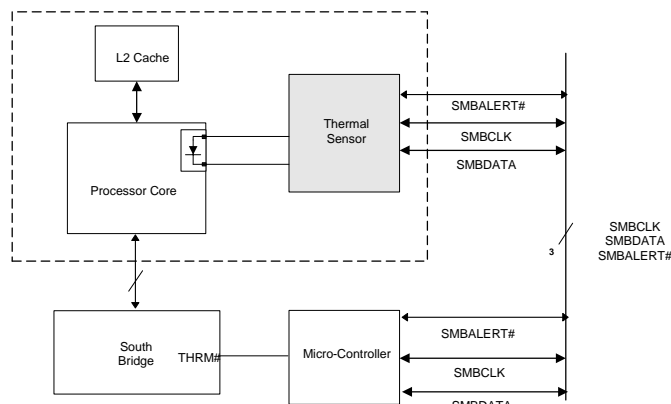
Figure 1. An Example of Microcontroller Driven Thermal Management

B30. Thermal Sensor May Assert SMBALERT# Incorrectly

Problem: The Mobile Pentium II processor and the Pentium II Processor Mobile Module have a thermal sensor that monitors the processor core's temperature. Please note that desktop systems could have a similar thermal device. The thermal sensor asserts SMBALERT# if the processor temperature exceeds the temperature limits set in the Alarm Threshold Registers (T_{HIGH} , T_{LOW}). It also sets the corresponding Status Register bits to identify the cause of the interrupt. Figure 1 gives one example of the how the SMBALERT# signal could be used in a system.

Under the conditions described below, the thermal sensor incorrectly generates the SMBALERT# interrupt. All of the following conditions must be met to trigger a false interrupt:
